# Seismic Damage and Disaster Reduction Analysis of Building Structures along the Surface Rupture Trace Line of Strong Earthquakes

**Keywords:** Surface Rupture; Building Structures; Fault; Disaster Reduction

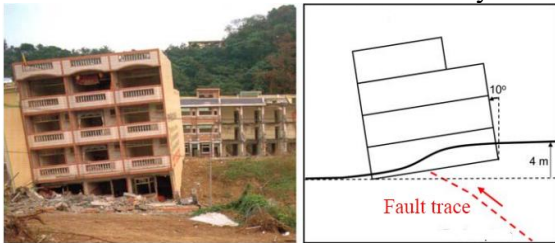
The 1999 Chiji earthquake generated a strong seismic surface rupture zone along the Chelongpu thrust fault, running almost north-south with a total length of about 100km<sup>[2]</sup>. The surface rupture zone caused a four story residential building near Fengzhen Park in Fengyuan City to be traversed by a strong earthquake surface thrust fault during the earthquake, causing serious damage. Due to being located on a continuous stiffness foundation, it did not collapse. The ratio of

buildings on both sides of the trace is 40:60, forming a 4m steep slope (gentle slope). At the same time, the building slopes downwards by  $10^\circ$ , as shown in Figure 1.

**Figure 1. Analysis Diagram of Structural Failure on Fault Traces**

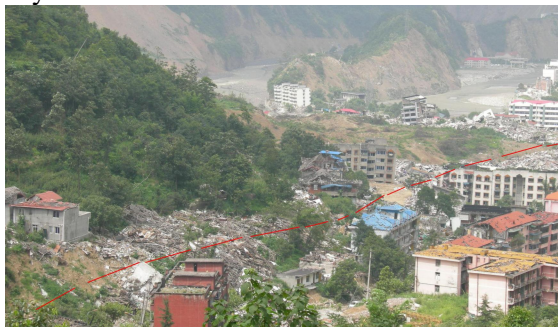
Jianyi Zhang and others have sorted out the seismic damage of engineering structures at a certain distance from the Wenchuan earthquake rupture line (see Figure 2). According to the principle of quantifying the relationship between structural seismic damage index and fault distance (trace distance from the building), the formula for seismic damage index (I) and rupture distance (S) is given as  $I=0.7463-0.00195S$ .

**Figure 2. Detailed Drawing of Buildings at Main Traces on Surface Rupture**

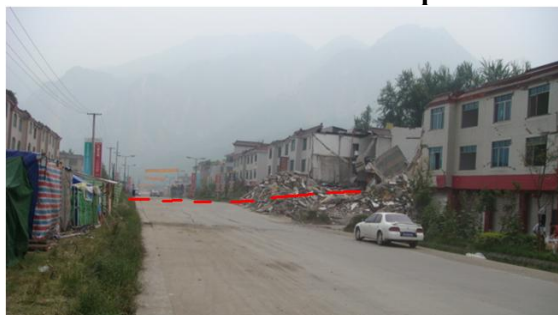
and structural columns, basically meeting the requirements for resisting strong earthquakes), and the surface rupture zone (trace) almost passes through in the most dangerous vertical way. The author's investigation found that houses within 20 meters from the trace completely collapsed. Serious damage to houses ranging from 20 to 50 meters (see Figure 3), moderate damage to houses ranging from 50 to 100 meters, and minor damage beyond 100 meters.

**Figure 3. Damage to Houses in the Secondary Branch Rupture of Xiaoyudong**

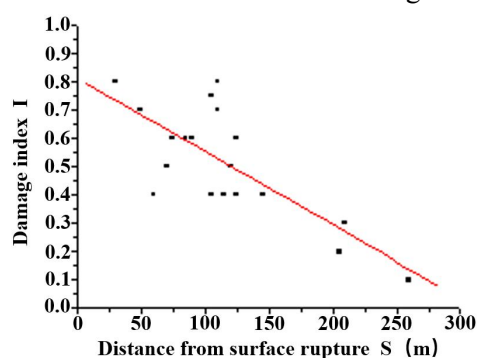
with the principle of “not collapsing during a major earthquake”; To achieve repairable damage below moderate, the distance from the rupture trace should be at least 150m; In the VIII degree zone, as the distance from the surface rupture (S) increases, the seismic damage index (I) of the hollow brick structure (Class D) greatly decreases, and the fitting formula is  $I=0.8132-0.0026S$ , in Figure 4.

**Figure 4. Trace Distance and Seismic Damage Index of Hollow Brick Structure**

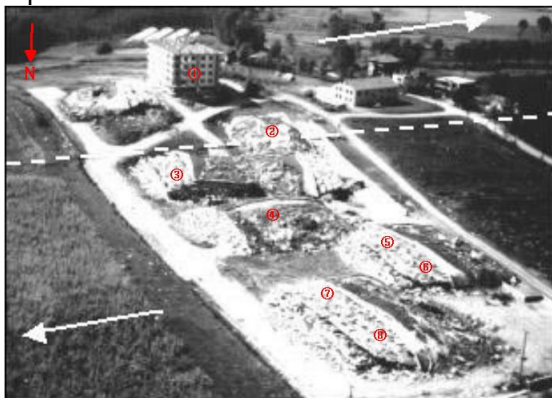
This article believes that this typical case occurred in 8 residential buildings with the same height, size, and construction quality, which is highly representative and reflects the hanging wall effect under the normal fault, as shown in Figure 5. However, the lower wall area hardly undergoes significant deformation under the surface rupture effect. The observation of a two-story building closer to the lower wall in the figure also stands, while the damaged buildings are all in the reverse steep slope area formed by the hanging wall. Through the analysis of the strong earthquake rupture effect of the buildings ③ and ④ and the damage of other houses, it can be seen that the distance between the upper wall and the trace line is at least 50-100m or more, which may not lead to the collapse or destruction of the buildings under the effect of surface rupture and vibration.

**Figure 5. Damaged of the Building in Kular Village with Normal Strike-slip Fault Trace**

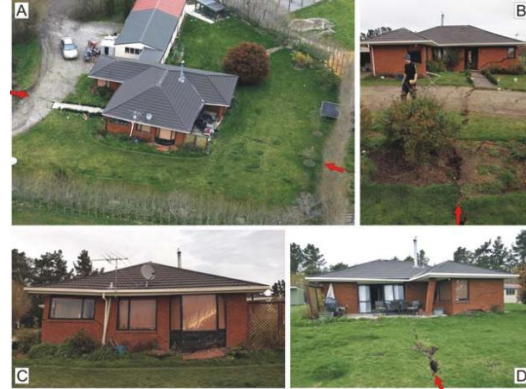
simple building with a wooden frame, brick load-bearing and lightweight roof on one floor, a concrete strip foundation, which is traversed by a strike-slip main seismic fault (the red arrow in the figure 6 shows the trace). During the earthquake, the wall has shear cracks, and the wooden column is crooked<sup>[7]</sup>, which is judged to be seriously damaged.

**Figure 6. Analysis Diagram of House Damage on Strike-slip Fault Trace**

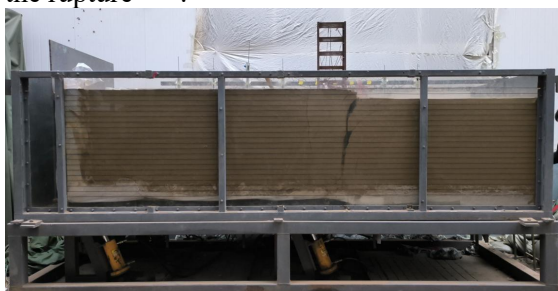
with high precision, and satisfy the reliability ratio of the box device and the foundation covering soil layer (Figure 7). The results showed that the seismic damage to the structure was most severe on the main rupture zone of the ground. Due to the rupture zone at this location, the maximum amount of surface non-uniform deformation caused by plastic deformation of the foundation increases the additional internal force of the upper structure. Therefore, foundation treatment and reinforcement are required at the location of the rupture<sup>[9-11]</sup>.

**Figure 7. Experimental Device for Frame Structure of Strong Earthquake Ground Rupture Site**
