Structural Safety Study of an Existing Wooden Roof Structure

2. Project Profile

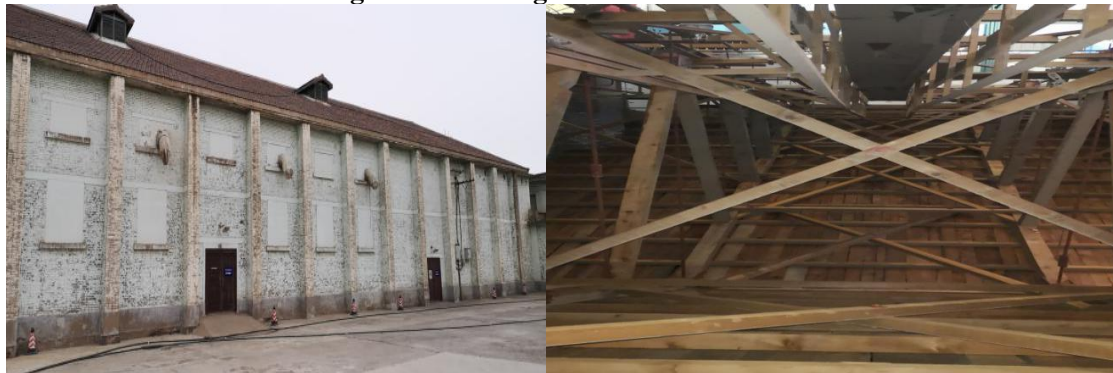
Figure 2. Map of the Current Status of Silverlight's Club as 2.0kN/m².

Due to poor drainage around the building leads to uneven settlement of the foundation, settlement difference does not meet the specification requirements; upper load-bearing structure part of the local masonry wall breakage, cracking, masonry mortar strength does not meet the specification

requirements; roof seepage, corrosion of the wooden roof rack, corrosion can not meet the requirements of the normal use of the function, the calculation of the wooden roof rack under

the chord of the T-shaped combination of double angle steel stress does not meet the specification requirements. The current situation is shown in Figure 2.
