Crack Analysis and Weldability Restoration of 800H Alloy High-Temperature Steam Pipelines

Yongsheng Zhang¹, Jinbao Zhang¹, Xiaoqiang Li²

This paper analyzes the causes of cracks in an 800H alloy high-temperature steam pipeline, specifically at the weld joints of the valve and the pipeline. Furthermore, it investigates the use of solution annealing heat treatment to improve the weldability of the alloy after aging, restore its microstructure, and extend the service life of the pipeline [9-10].

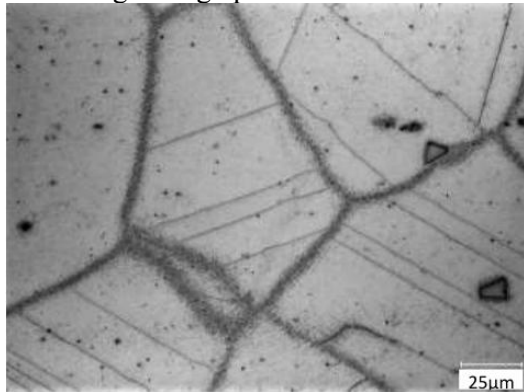
As shown in Figure 2, metallographic examination of the 800H samples revealed significant precipitation of carbides at the grain boundaries. These carbides were identified as Cr₂₃C₆, a typical product of prolonged high-temperature operation for 800H alloys. The measured grain size was ASTM 3.5, with no evidence of grain growth, indicating that the pipeline had not undergone overheating during operation.

Figure 2. Grain Boundary Precipitation of Carbides in 800H Pipeline Samples

material, suggesting that the carbide precipitation observed in the metallographic examination (Figure 2) does not significantly deteriorate the toughness or ductility of the material. This indicates that the mechanical properties remain unaffected to a degree that could trigger crack formation.

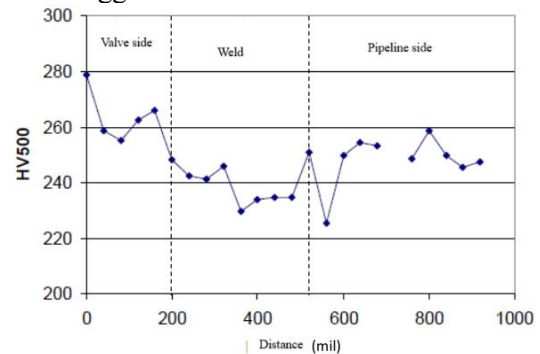
Microhardness measurements were conducted on the 800H samples using a 500 g load, and the results are presented in Figure 3. The hardness of the valve side ranged from 250 to 280 HV, slightly higher than the values observed for the weld and pipeline sides. The hardness of the Inconel 82 weld ranged from 230 to 250 HV, while the pipeline side of the 800H exhibited hardness values between 240 and 260 HV. As shown in Figure 3, cracks were detected on the pipeline side near the HAZ of the weld. However, the hardness values in this region did not reveal any abnormalities. The measured hardness values fell within the normal range for 800H alloy

Figure 3. Microhardness Measurements of the Samples

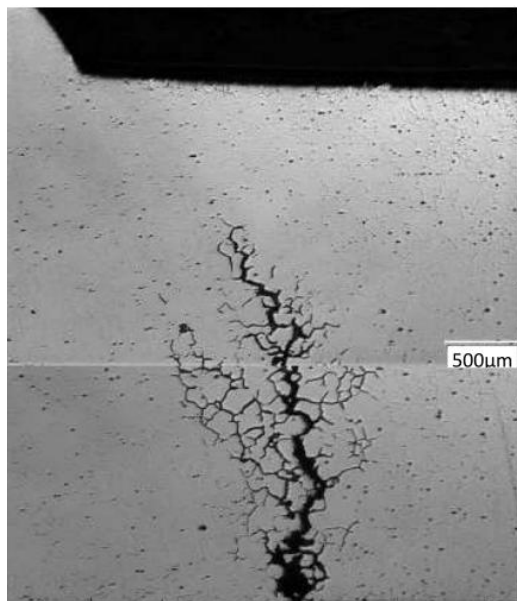
The cross-section of the metallographic sample, prepared through standard metallographic procedures, was examined under an optical microscope, revealing the detailed morphology of the cracks (Figure 4). The examination results show that the crack did not penetrate the entire pipeline wall, with approximately 20% of the wall thickness remaining intact. Due to the relatively low operational steam pressure within the pipeline, the remaining 25% wall thickness ensured the continued operation of the pipeline without resulting in a rupture accident. Furthermore, the timely detection of the crack ensured the safe operation of the unit. The specific morphology of the crack exhibited a dendritic pattern, with its root clearly originating from the inner wall of the pipeline. This indicates that the crack initiated on the inner wall and

propagated outward toward the outer wall. The crack displayed significant branching, with the number of branches increasing as it progressed toward the outer wall. These crack characteristics are consistent with the behavior of stress cracks, suggesting that stress played a critical role in the crack formation mechanism.

Figure 4. Morphology of Cracks in the Pipeline

The cracks occurred at the connection between the valve and the pipeline, where significant differences in the dimensions of adjacent components were present. Additionally, variations in alloy composition, microstructure, and stress across the weld resulted in high thermal and constraint stresses at the failure location. Based on the metallographic examination and analysis conducted above, the cracking mechanism has been identified as stress relaxation cracking (SRC).

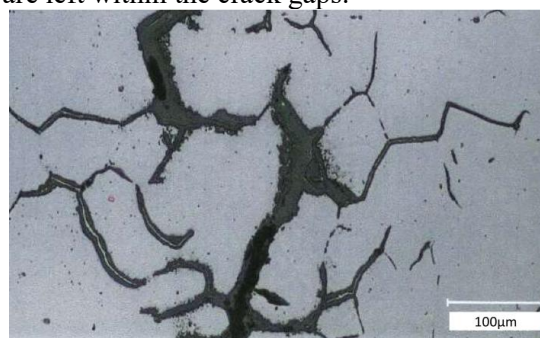
Upon closer observation of the crack morphology, it was noted that the crack gaps were filled with oxides (Figure 5). Since high-temperature steam flows along the inner wall of the pipeline, the 800H alloy undergoes an oxidation reaction at elevated temperatures, resulting in the formation of oxides within the crack gaps. Another distinct feature of the cracks is the presence of white, filamentous structures in the center of the gaps. Further analysis using scanning electron microscopy identified the oxides within the cracks as chromium-rich oxides, primarily chromium oxide (Cr_2O_3). The white filamentous structures in the crack gaps were found to be unoxidized metals enriched in nickel (Ni) and iron (Fe). This crack morphology, along with the oxides and filamentous metal structures within the gaps, is consistent with the characteristics of stress relaxation cracking observed in stainless steels and iron-based alloys. In high-temperature, oxygen-rich environments, metals within the crack gaps undergo oxidation reactions. For chromium-containing alloys, chromium oxide is predominantly formed. As chromium oxide forms, the oxygen partial pressure within the

crack gaps decreases. For stainless steels and iron-based alloys such as the 800H alloy, iron, chromium, and nickel are the primary alloying elements. In high-temperature oxidation environments, the partial pressure of oxygen required to form iron oxide and nickel oxide is significantly higher than that required to form chromium oxide. Thus, as chromium oxide forms and grows, the oxygen partial pressure continues to decrease. When the oxygen partial pressure drops below the level needed to form iron oxide and nickel oxide, unoxidized filamentous metal structures, primarily composed of iron and nickel alloy components, are left within the crack gaps.

Figure 5. Cracks Filled with Oxides and Unoxidized Filamentous Metals

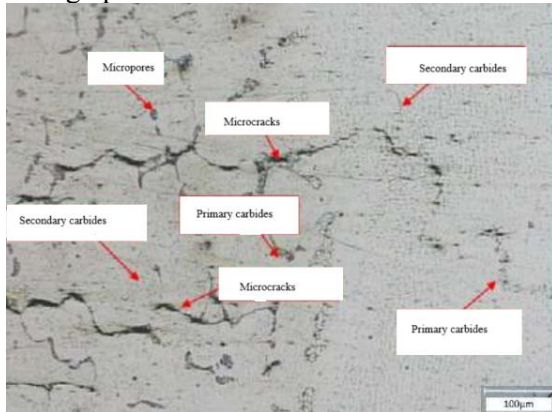
To repair the 800H pipeline, TIG welding tests were conducted on samples extracted from the 800H alloy after service. Post-welding non-destructive testing revealed no cracks or defects exceeding permissible limits. However, metallographic examination of the cross-section showed signs of performance degradation in the 800H alloy (Figure 6). Figure 6 illustrates the presence of microcracks along the grain boundaries, with microscopic observations indicating that these microcracks extended from the base material to the fusion zone. Additionally, micropores

present within the alloy's structure had spread from the grain boundaries into the grain interiors. These microcracks and micropores not only pose a risk of inducing welding cracks but also contribute to the formation of creep cracks during high-temperature service. This, in turn, could lead to cracking of the aged 800H alloy, creating safety hazards during operation.

Figure 6. Metallographic Image of TIG Welded 800H Alloy Sample

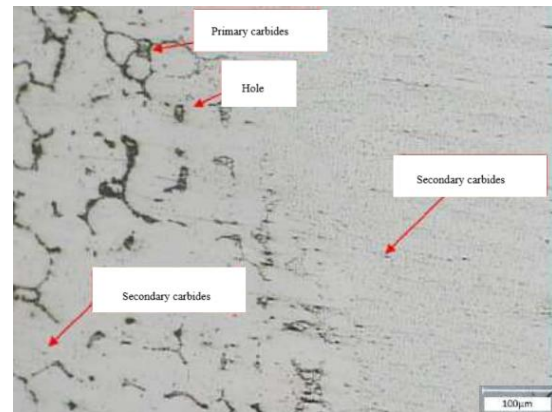
Figure 7. Metallographic Image of Welded 800H Sample after Solution Treatment

To repair the cracks and restore the usability of the 800H alloy pipeline, a solution annealing heat treatment study was conducted on the sampled 800H alloy. The primary objective of this process was to remelt the carbide precipitates, enhance the alloy's ductility, and improve its weldability. Solution annealing also helps to eliminate residual stresses, thereby reducing the likelihood of crack formation during welding and operation. The solution annealing heat treatment was performed in accordance with the requirements for 800H alloy specified in ASME Section II Part B, with the solution treatment temperature and duration set at 1150°C for 30 minutes. After undergoing solution annealing, the 800H alloy samples were subjected to TIG welding tests. Post-weld non-destructive testing revealed no cracks or defects exceeding permissible limits. Further metallographic cross-sectional examination confirmed the absence of welding cracks (Figure 7). The microstructure of the solution-annealed alloy exhibited the presence of primary carbides, secondary carbides, and microscopic pores. However, no microcracks were observed after welding. The reduction in residual stress significantly decreased the probability of crack formation during welding. Additionally, solution heat treatment minimized the residual stresses that could

otherwise promote the diffusion of micropores, preventing their coalescence and the initiation of microcracks.
