Treatment of a Landslide in Sichuan

Abstract: The article provides a detailed description of the shape and deformation characteristics of a certain slope, analyzes the harmfulness of the slope, proposes a support design scheme, and explains the construction techniques of each sub item.

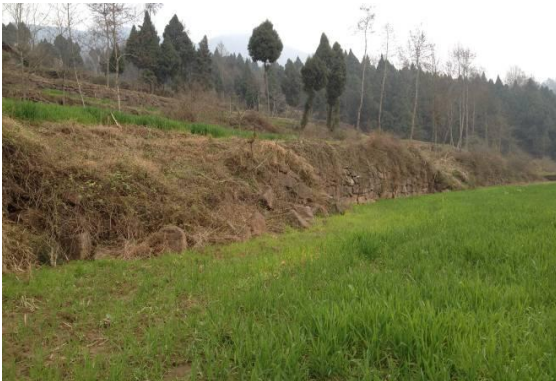
Figure 1. Collapse of the Front Edge of the Landslide and Tilting of Trees

Front edge of landslide: the steep slope at the front edge of the landslide is about 2-3m high, with obvious swelling visible, and some areas have collapsed. the spring point at the bottom of the fortress is exposed in a linear pattern.

The strong deformation zone is about 130m wide and 125m long along the slope. the front part of the slope is messy, with trees skewed and signs of deformation mainly concentrated in this area. In addition, bulging phenomenon can be seen on the dry block stone retaining wall next to the drainage ditch on the inner side of the highway. After analysis, it was found that under the condition of saturated slope, the excavation of the slope formed a free face, and local residents built houses on the retaining wall, resulting in local small-scale deformation of the slope.

Gravity retaining walls are used to support the

collapsed bodies on the inner side of the highway and the high steep slope deformation zone at the rear of the strong deformation zone.
