Stability Analysis and Treatment Measures of a Landslide

Zeng Yuping

Sichuan College of Architectural Technology, Deyang 618000, Sichuan, China

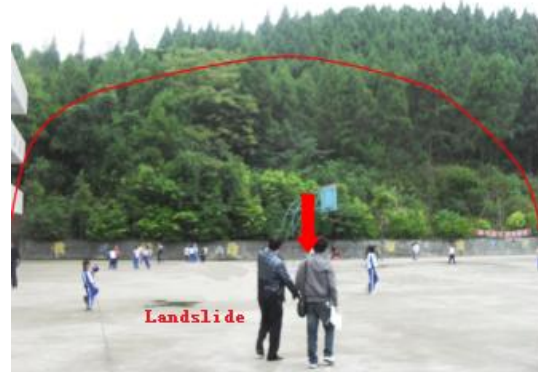
The landslide is located in Langzhong City, Sichuan Province, and the landform in the survey area is a middle hill area of tectonic denudation, which is inclined, with an altitude of 300~500m, which is mainly characterized by high terrain in the east and low in the west. Due to the stacking of sand and mudstone, soft and hard, the slope is partially formed with small steps, the steps are generally 20~50m wide, and the valley slopes on both sides are relatively low and gentle, and the valley width is 10~50m. the main valley is wide and flat, medium landform, and the cutting depth of the valley is generally 50~100m, so the slope of the valley slope is about 20°, and the local slope is greater than 60°. the landslide is semi-arc-shaped on the plane of the exploration area, and the landslide plane is semi-arc-shaped, with a longitudinal length of about 50m and a width of about 80m, which is a traction landslide, with an area of about 4000m², a thickness of about 1.5~7.0m, and a volume of about 15, 000m³. the elevation of the front edge of the slope is about 324m, the elevation of the ridge at the back edge is about 370m, and the relative elevation difference is about 46m. the slope slope is about 20°~60°, the average slope is about 31°, and the landslide direction is 265°, see Figure 1.

(1) Front edge fence: the original fence inside the playground at the front edge of the landslide was buried by the sliding of the upper landslide during the rainstorm in August 2009, and the existing fence was deformed during the rainstorm in August 2011. At present, the fence is inclined, about 10 ° to the outside of the slope; the surrounding wall has cracked locally, forming three cracks with a length of about 5-7.5m and a width of about 2-5cm. There is groundwater seepage at the corner of the left wall.

(2) Landslide front edge: During the rainy season from 2009 to 2011, the ground cracked and the front edge slope collapsed, forming a local landslide ridge with a length of about 10-30m and a height of 2-6m. the trees on the upper part of the leading-edge slope are skewed.

(3) In the middle of the landslide: During the rainy season from 2009 to 2011, two cracks LF1 and LF2 appeared on the ground in the middle of the landslide. LF1 was about 35m long and 2cm to 10cm wide, with a strike of 185 °. LF1 experienced local sliding during the rainy season, forming a landslide ridge with a height of about 0.6-1.5m. LF2 is approximately 25m long, 2cm to 8cm wide, and runs at an angle of 190 °.

Figure 1. Overall view of the landslide

(1) the front edge of the landslide collapsed significantly, mainly due to surface sliding. An anti slip pile was built on the inner side of the front edge wall to block the upper sliding body. Set a retaining wall of 100.0m, with a height of 4.0m, an embedded depth of 1.0m, a bottom width of 3.0m, a top width of 1.0m, a slope of 1:0.2 for the face slope, and a slope of 1:0.2 for the back slope. Adopting one extended wall toe step, with a width of 0.5m and a height of 1.0m, and a slope of 1:0.2 on the wall toe step surface. the wall is constructed with MU30 mortar block stones.

(2) At the rear edge of the landslide, it is recommended to rectify and harden the existing excavated drainage ditch, and intercept and drain surface water on the slope. the drainage ditch is planned to be arranged at the rear edge of the landslide, consisting of a transverse intercepting ditch, a steep slope, and a waterfall, with a total length of about 125 meters. Install drop water energy dissipation wells at steep slopes, and set up rapid flow

The landslide mass has formed a large number of cracks on the slope during its previous deformation process. Although these cracks do not show obvious signs of widening at present, they are easily penetrated by the cracks during the rainy season, increasing the weight of the slope and affecting its overall stability. Therefore, it is necessary to seal and fill the cracks on the slope. the amount of crack sealing and filling is about 40m, using high-quality clay and lime for sealing and compacting.
