Analysis and Treatment Design of a Landslide Deformation Mechanism

Zeng Yuping

Sichuan College of Architectural Technology, Deyang, Sichuan, China

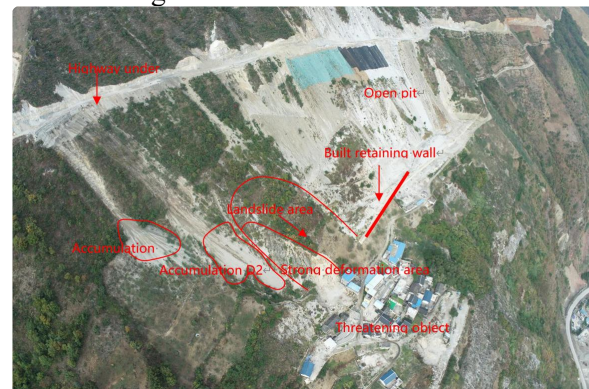
The overall length of the landslide area is about 95m, the average width is about 75m, the thickness of the sliding body is 15~20m, the volume is $10.7 \times 10^4 \text{m}^3$, and the main slip direction is about 120° . The elevation of the front edge of the landslide is about 1129.8~1133.11m, the elevation of the trailing edge is about 1177.17~1172.01m, the relative height difference between the front and rear edges is about 39~48m, and the right side of the front edge is air-empty, which creates favorable terrain conditions for the generation of landslides. The scale of the landslide is medium-sized soil landslide. The landslide pattern is shown in Figure 1.

Figure 1. Landslide Satellite Image Overview

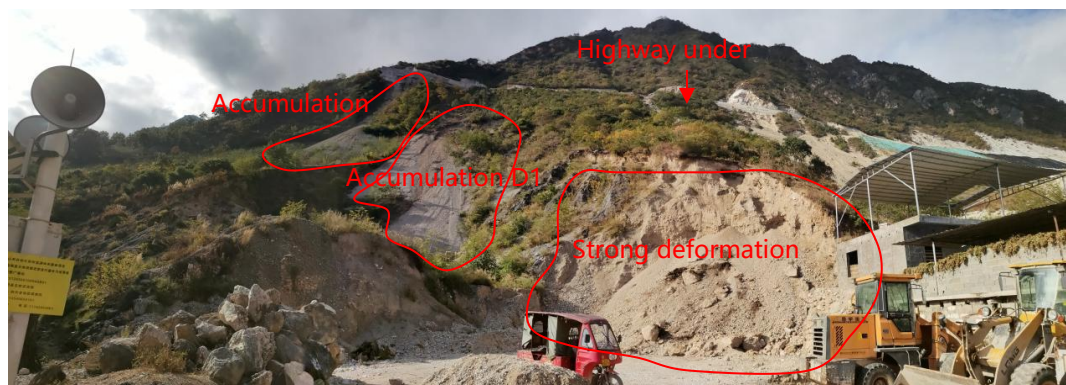
According to this survey and combined with the visit, two adverse geological hazards accumulated due to the construction of highway waste on the left side of the slope, which is easy to form a broken debris flow under heavy rainfall conditions. The landslide area is located on the right side of the slope, and the strong deformation area of the leading edge has collapsed, which develops every rainy season. The overall view of the landslide of the Degugou Formation is shown in Fig. 2.

Figure 2. Landslide Overview

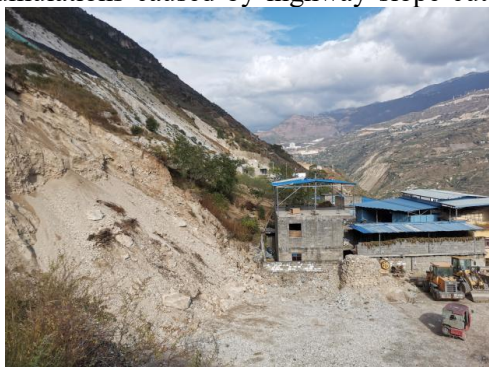
The strong deformation zone is located near the shear outlet of the landslide front, as shown in Figure 3. The deformation zone is arc-shaped, with a width of about 50m and a height of about 30m. Two adverse geological hazard accumulations caused by highway slope cutting

Figure 3. Landslide Leading Edge Slump

① Pile-sheet walls shall be installed on the left side of the landslide leading edge (covering the strong deformation zone and platform). The proposed pile-sheet walls and the existing gully platform will form a debris storage zone to restrict the lateral and forward movement of the landslide mass.

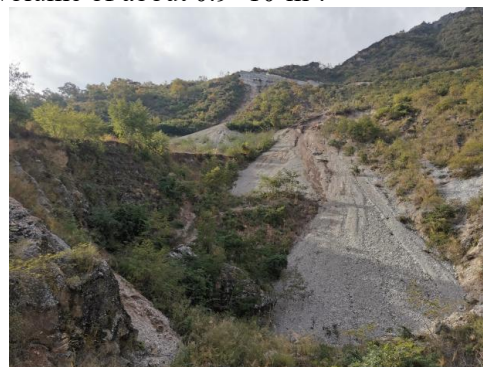
at the upper left of the slope are shown in Figure 4. Accumulation body D1 is located at the upper left of the landslide, with a total volume of about $0.5 \times 10^4 \text{m}^3$, and accumulation body D2 is located at the upper left of the landslide, with a total volume of about $0.9 \times 10^4 \text{m}^3$.

Figure 4. Road Slope Cut Waste Slag Accumulation Body

condition of heavy rainfall, hydrodynamic action is easy to form slope debris flow.

③ Diversion dikes or gabions shall be constructed at the two unfavorable geological hazard accumulation sites to guide the debris sources into the lower gully platform, eliminating the debris flow risk.
