Analysis of Influencing Factors of a Dangerous Rock Deformation Body

Zeng Yuping

Sichuan College of Architectural Technology, Deyang, Sichuan, China

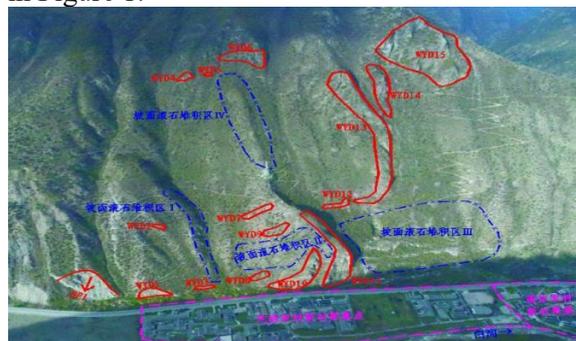
Figure 1. Dangerous Rock Mass Topographic Map

gradient of $75^{\circ}\sim 85^{\circ}$; local sections are sheer cliffs where dangerous rocks stand tall. At the foot of the slope, some sections are steep slopes with a gradient of $45^{\circ}\sim 65^{\circ}$, while others are gentle slopes with a gradient of $15^{\circ}\sim 30^{\circ}$. The main threat targets of the entire dangerous rock area are Provincial Highway 301 and the new village below the slope. The topographic features of the dangerous rock mass are shown in Figure 1.
