# Microstructural Characterization and Cause Analysis of Fracture Surface Burrs in Lockbolts

**Abstract:** Lockbolts are a category of rivets widely applied in bridge steel structures, mining machinery, rail transit and other fields. After installation, its fracture surface must be regular and free of sharp burrs. Previous inspections identified sharp burrs on the fracture surfaces of some production batches after pintail break-off, indicating noncompliance with the product specifications. Samples exhibiting abnormal fracture surfaces were subjected to systematic failure analysis, including low-magnification examination of acid-etched longitudinal sections, longitudinal metallography, macroscopic and microscopic fractography, and energy-dispersive X-ray spectroscopy of longitudinal sections. The abnormal fracture surfaces were ultimately attributed to banded segregation of Mn or C in the lockbolt core. Differences in solute content disrupted the homogeneity of the steel and produced alternating bands with different ductility and toughness. Under tensile loading, sliding along the segregation bands generated axial cracks. These cracks interacted with transverse cracks originating a

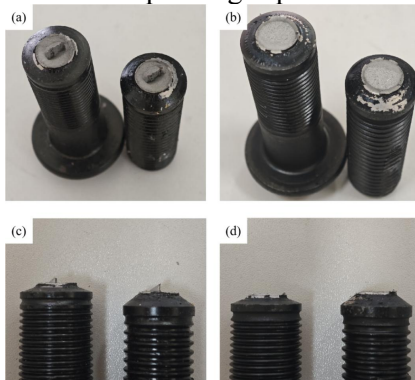
The macroscopic appearance of lockbolts with fracture surface burrs is shown in Figure 3(a, c), while lockbolts with normal fracture surfaces are shown in Figure 3(b, d). The uneven fracture surfaces exhibited sharp burrs in the core. Each burr had a relatively smooth inclined face on one side and an axial, woody fracture surface on the other, with a corresponding depression beneath it.

**Figure 3. Lockbolt Fracture Surfaces: (a, c) Abnormal Fracture Surfaces; (b, d) Normal Fracture Surfaces**

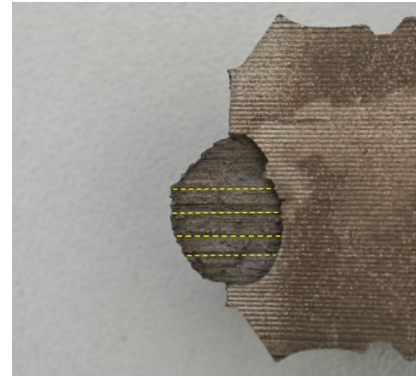
Lockbolts with particularly severe burrs were selected from the same production batch and sectioned as illustrated in Figure 4. The fracture surfaces were examined first. The macroscopic image in Figure 5 shows a distinct woody fracture morphology. According to the literature [7], woody features on tensile overload fracture surfaces generally indicate elemental segregation or inclusions that deflect the crack propagation path during tension. Industrial experience suggests that an axial woody fracture morphology in the core is associated with corresponding banded features in the material, such as banded martensite, sorbite, or segregation bands.

**Figure 5. Macroscopic Appearance of the Lockbolt Fracture Surface**

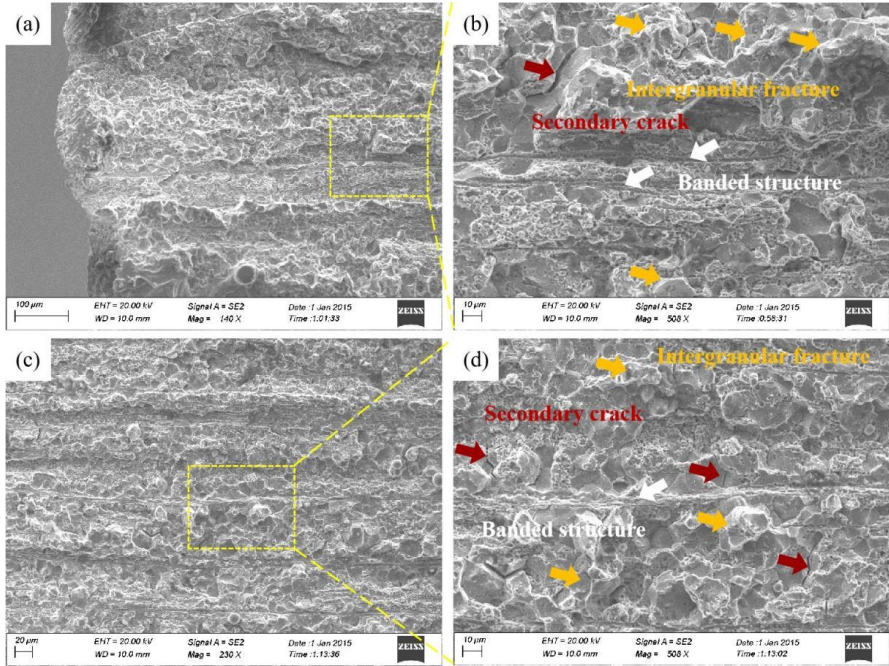
Scanning electron microscopy (SEM) revealed extensive intergranular fracture and numerous secondary cracks on the fracture surface, as shown in Figure 6. These features were tentatively attributed to grain-boundary segregation. A small number of quasi-cleavage facets were also observed elsewhere, as shown in Figure 7. Under normal conditions, grain boundaries have greater cohesive strength than the grain interiors. However, impurity enrichment or precipitation of brittle second phases at grain boundaries can make them preferential paths for crack propagation, resulting in intergranular fracture [8]. Energy-dispersive X-ray spectroscopy (EDS) at the bottom of the woody grooves, shown in Figure 8, revealed markedly elevated Mn and S contents, suggesting possible Mn segregation or MnS inclusions.

Figure 6. Micrographs of Different Regions of the Lockbolt Fracture Surface

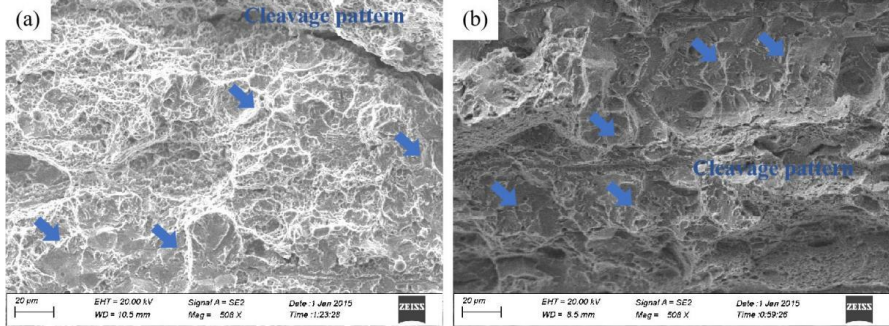
Figure 7. Micrographs of the Lockbolt Fracture Surface

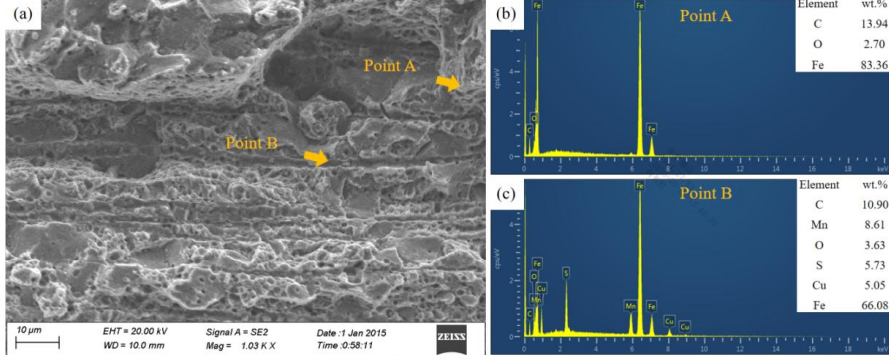
Figure 8. EDS Results for the Lockbolt Fracture Surface

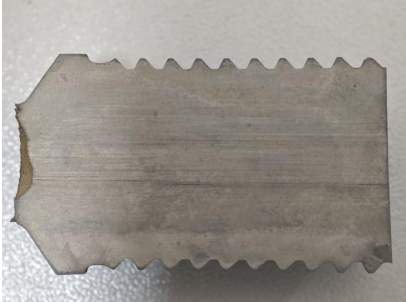
To further identify the cause of the woody fracture morphology, the internal structure of the samples was examined. Low-magnification observation of acid-etched longitudinal sections was performed first, as shown in Figure 9. Numerous dark segregation bands were observed along the axial direction in the core.

Figure 9. Longitudinal Macrostructure of the Lockbolt

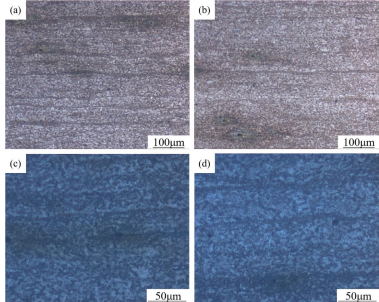
The samples were then examined metallographically, as shown in Figure 10. Dark axial bands were present in the core both near and away from the fracture surface. At higher magnification, these bands showed no distinct grain boundaries and were provisionally identified as Mn or C segregation bands.

Figure 10. Longitudinal Microstructure of the Lockbolt

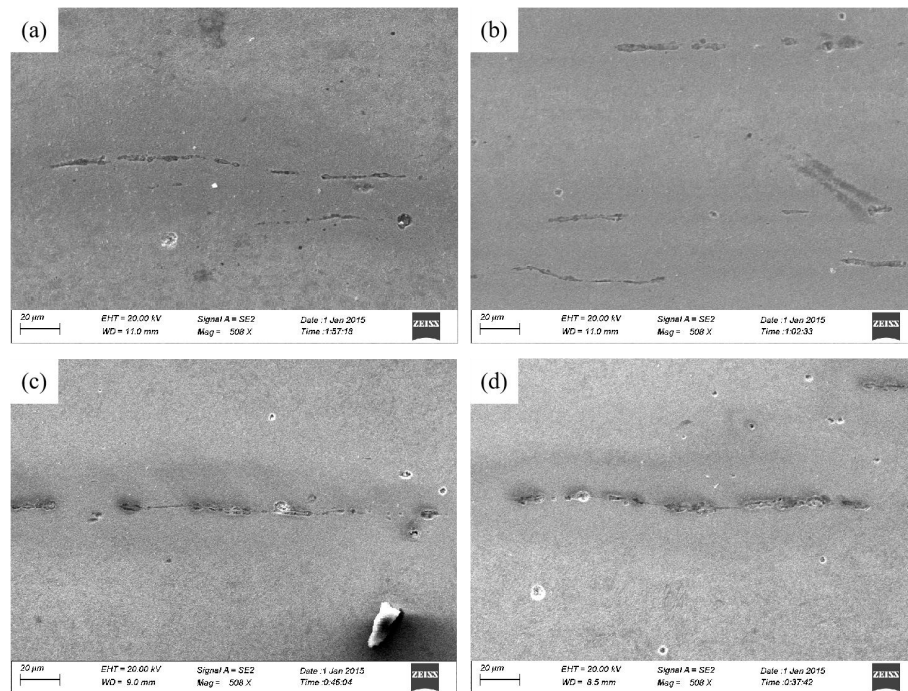
SEM examination was conducted to further characterize the banded structure, as shown in Figure 11. Figure 12 shows elongated etch depressions extending along the axial direction in the sample core. EDS confirmed Mn and C segregation within these bands. Solute-rich segregated regions are etched more rapidly and therefore generally appear as dark etch depressions [9].

**Figure 11. SEM Images of Axial Segregation Bands at Different Locations in the Lockbolt**

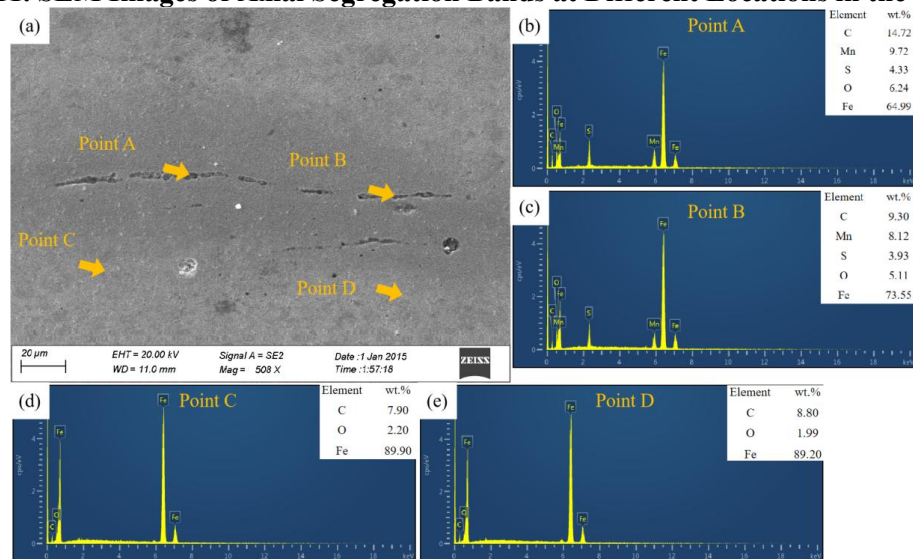
**Figure 12. EDS Results for Axial Segregation Bands in the Lockbolt**

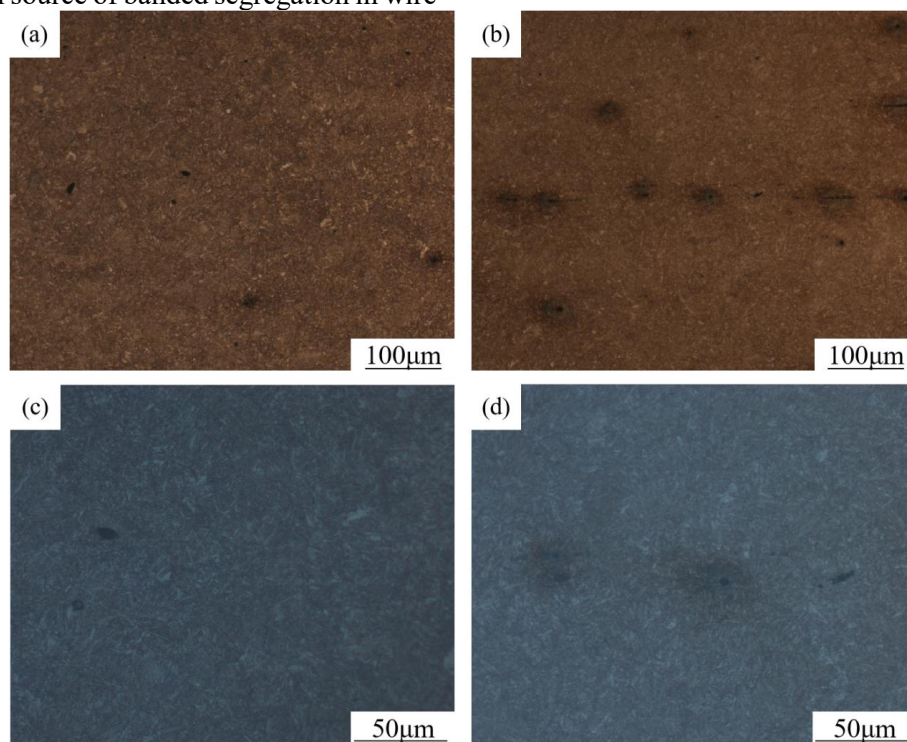
**Figure 14. Microstructure of the Lockbolt after High-Temperature Diffusion Annealing**

Lockbolts that previously exhibited severe fracture surface burrs were subjected to diffusion annealing at  $1050^\circ\text{C}$  for 4 h, followed by quenching and tempering. This treatment substantially reduced burr formation. Samples from the treated batch were examined metallographically, as shown in Figure 14. Axially aligned metal flow lines were no longer visible in the longitudinal sections. The previously continuous segregation bands had become spheroidized and discontinuous, indicating a substantial reduction in banded segregation.
