# Discussion on the Frequent Burning and Erosion of Marine Medium-Speed Diesel Engine Valves: A Case Study of MAR 8N330 Diesel Engine

Valve burning and erosion is a common malfunction in diesel engines, posing significant maintenance challenges for marine engineers. Colleagues in China have extensively researched this issue and summarized useful experiences. The main diesel engine model on my ship is MAR 8N330, with a rated speed of 400r/min. Every time the ship operates in the Middle East region, the phenomenon of valve burning and erosion occurs frequently. In severe cases, one or two valves may burn out within a day (see Figure 1 and Figure 2), greatly increasing the workload of the crew and the consumption of spare parts. Based on recent work practice, by

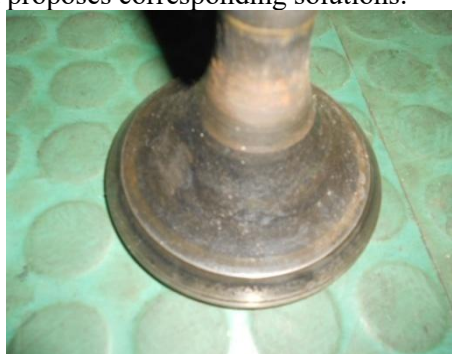
Figure 1. Mild Erosion

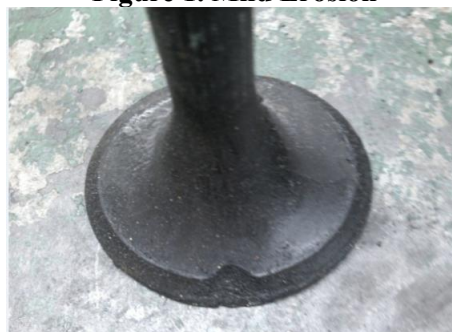
Figure 2. Severe Erosion

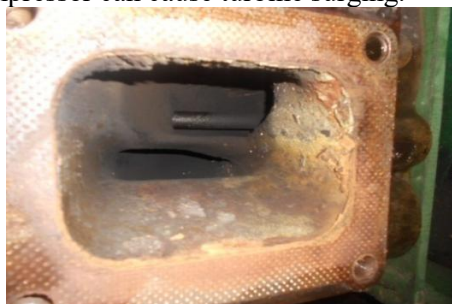
The intake and exhaust system is the respiratory system of a diesel engine. When it experiences carbon deposition or clogging, it directly affects the engine's operating condition. Common blockages in the intake system occur at the turbocharger inlet filter, blades, air side of the intercooler, and cylinder head intake ports (see Figure 3 and Figure 4); while blockages in the exhaust system often occur at the turbine front grille, nozzle ring, nozzles, and the smoke tubes of waste heat boilers without bypass. Blockage in any part of the intake and exhaust system can cause a decrease in turbocharger power, reduced air intake, lowered air density, poor combustion, increased carbon deposit, elevated exhaust temperatures, and consequently valve burning. Additionally, the reduced airflow through the compressor can cause turbine surging.

Figure 3. Slight Blockage

- (1) Ensure regular flushing of the turbine during navigation and maintain the quality of flushing. However, if the turbine has not been flushed for a long time, it is better not to flush it to avoid incomplete cleaning and disturbing the dynamic balance.
- (2) Regularly check and clean the intake air filter, intercooler, scavenging pipe, and intake ports.
- (3) Perform timely ash blowing and cleaning of the exhaust gas boiler and flues.
- (4) As an eight-cylinder engine, with equal throttle settings, cylinders 1 and 2, which are farthest from the turbocharger, have noticeably higher exhaust temperatures. The throttle should be appropriately reduced to control the exhaust temperature.

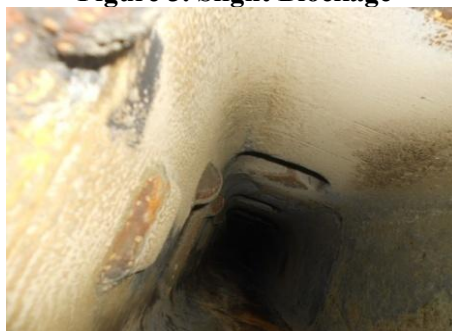
Figure 4. Severe Blockage
