A Landslide Treatment Technology

Abstract: This article provides a detailed description of the basic characteristics and material structure of a landslide, analyzes the stability of the slope, proposes a support design scheme, and explains the construction techniques for each sub item.

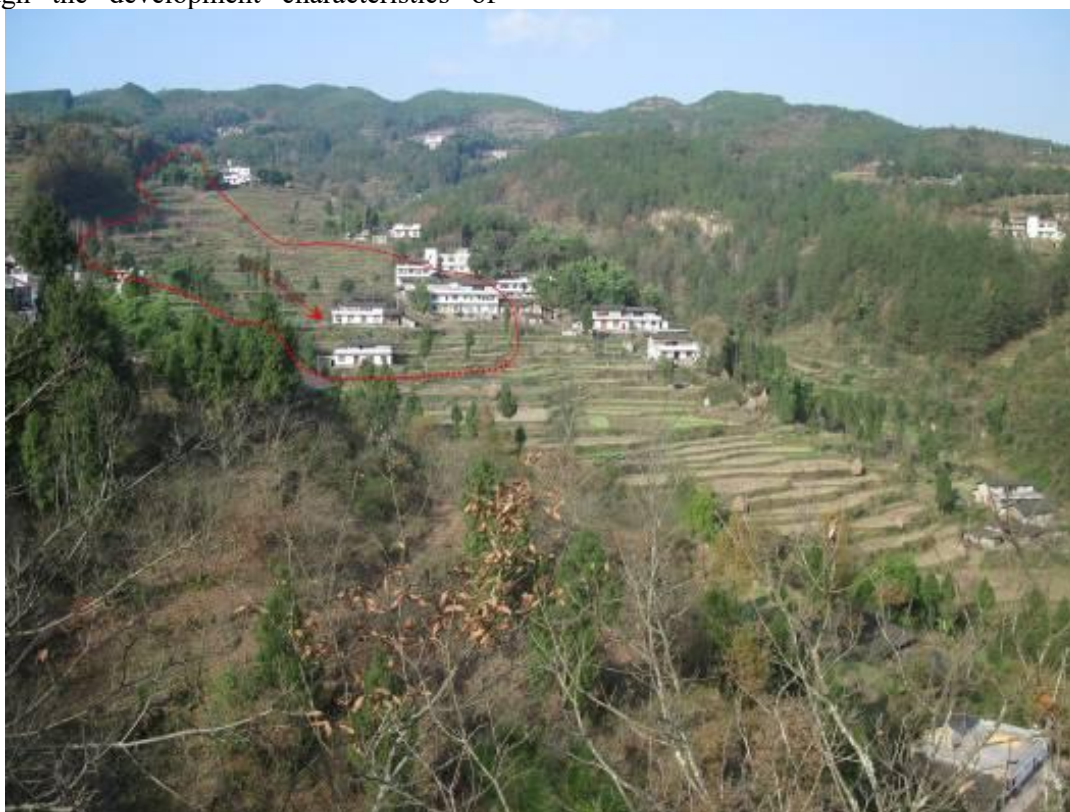
Figure 1. Overall View of Landslide

According to the different deformation conditions of landslides, they are divided into strong deformation zones and weak deformation zones. the strong deformation zone of the landslide is located in the middle and rear of the landslide, with a valley shaped plane and a low-lying terrain compared to the surrounding terrain. the rear edge and both sides of the strong deformation zone are bounded by the landslide boundary, and the front edge to the boundary area where the deformation weakens sharply and gently. the other areas are weakly deformed zones. the strong deformation zone began to deform in the 1990s, and after a heavy rainfall, the rear edge began to move downwards by 0.4-0.5m, forming three long cracks on both sides. Since 2009, there has been a general rainstorm in Bazhong area, and the landslide deformation has intensified. Cracks have appeared in the east and front edge of the strong deformation area, and houses in the east of the weak deformation area have also been deformed.

The landslide is located in the central part of the county, with a generally southward sloping single-sided mountain slope. the slope is mostly paddy fields, with some areas being dry land. On the west side of the landslide is a steep cliff with exposed bedrock, ranging from 10-40m in height. the rock type is sandstone from the Shaximiao Formation of the Jurassic System. On the east side, there is a line between the middle gully and the inclined rock gully of the slope. the rear edge is the boundary between steep and gentle terrain, and the front edge is located in a relatively low and gentle depression with a thick soil layer. the elevation of the rear edge of the slope is 820m, the elevation of the front edge is 671m, and the relative height difference is 149m (see photo 4-1).

The Erhuangping landslide is located in San She, Bailiang Village, Ganchang Town, with a geographical range of $N32^{\circ}23'13'' \sim 32^{\circ}23'31''$ and $E106^{\circ}54'31'' \sim 106^{\circ}54'39''$. The rear edge elevation is 804m, the front edge elevation is 725m, the relative height difference is 79m, and the plane is "water bottle shaped". Most of the landslide area is paddy fields, which form a stepped shape from high to low.
