Deformation Analysis and Treatment of a Landslide

Abstract: The article provides a detailed description of the characteristics of landslides, analyzes landslide stability, calculates stability safety factors under different working conditions, and finally proposes control measures.

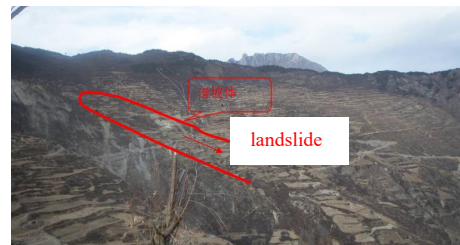
Figure 1 Overall View of Landslide

The landslide is located in the northwest of Sichuan Province and belongs to the eroded and eroded Zhongshan landform. According to the on-site survey, the elevation of the landslide's rear edge is between 3720 and 3740m, and the elevation of the front edge is between 3420 and 3470m, with a relative height difference of 270 to 300m. the landslide appears as an irregular strip on the plane, with gullies as the boundary on both sides, steep and gentle slopes at the rear edge, and steep slopes at the front edge of residential areas. the main sliding direction of the landslide is 169° . the average width of the landslide is about 250m, the inclined length is about 800m, and the sliding area is about $200.0 \times 103m^2$. the sliding body is composed of silty clay containing gravel, with an average thickness of about 12m. It is a mid-level landslide with a volume of about $240 \times 104m^3$. According to the "Code for Investigation of Landslide Prevention and Control Engineering" (DZ/T0218-2006), the scale grade of this landslide belongs to a large-scale landslide, as shown in **Figure 1**.

(1) It has the characteristics of small deformation in the front part of the landslide and large deformation in the middle and rear parts. According to the investigation and visits, the main deformations of the landslide are: tensile cracks appeared at the trailing edge of the landslide before the earthquake, there was a local landslide in the middle and rear of the landslide, behind the residential gathering area, and a descending spring appeared at the landslide; the 5.12 earthquake reduced the stability of the landslide, which not only increased the deformation of the tension crack at the trailing edge, but also produced new tension cracks in the front part of the landslide. In the middle of the left side of the landslide, the houses were cracked due to the deformation of the slope surface due to the deformation of the surface of the house, which had a great impact on the life and safety of the residents.

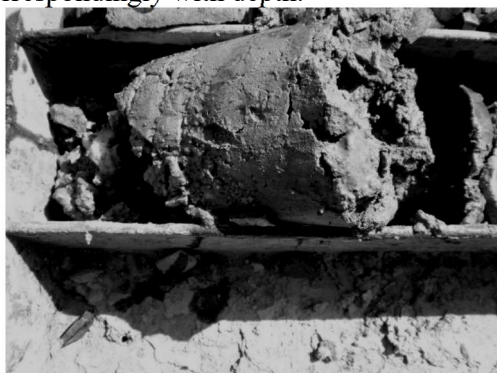
Figure 2. Soil Near The Slip Surface Slip Zone

According to the drilling data during the exploration phase, the sliding zone soil is revealed: some boreholes are located near the contact between gravel containing silty clay and gravel soil, mainly composed of silty clay, with less gravel content and smaller particle size than the upper gravel. the gravel has a certain arrangement pattern and is relatively soft in strength. the rock core is in the form of debris, damp, with a particle size of generally

2-15mm and a layer thickness of about 0.2-0.3m. This is mainly due to the sliding and sliding of the soil in this layer. Through analysis and judgment, this layer is the sliding surface of this landslide, as shown in **Figure 2**.
