Stability Analysis and Treatment of a Landslide

Abstract: In this paper, the characteristics of the landslide are described in detail, the stability of the landslide is analyzed, the stability safety factor under different working conditions is calculated, and finally the treatment measures are proposed.

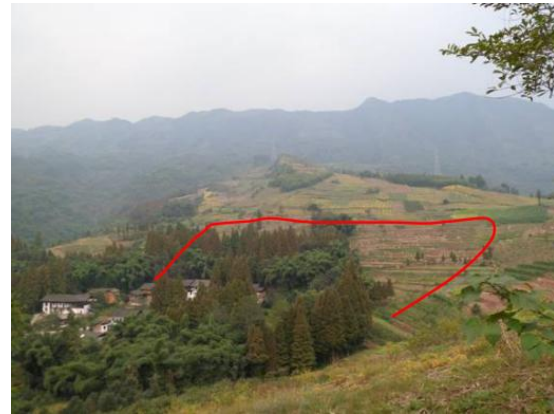
Figure 1. Overall View of Landslide

quadrilateral, as shown in **Figure 1**. the longitudinal length of the landslide is about 160m, and the transverse width is about 250m. the overall slope is straight and slightly arch-shaped. Outside the right boundary, the slope direction turns into a circle, the middle part protrudes into a ridge, and the overall slope direction is 150°. the slope has a gentle slope at the rear edge and a relatively steep front edge, and a gentle platform and a steep front edge are developed, with an overall slope of about 22°.
