Structural Safety Study of an Existing Wooden Roof Structure

2. Project Profile

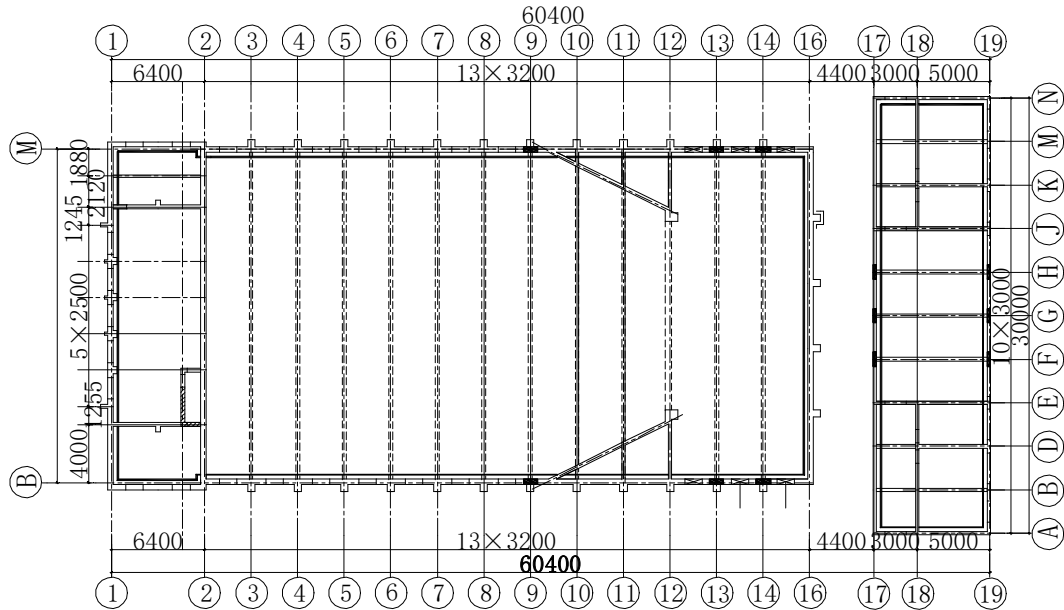
Figure 1. Silverlight's Club Floor Plan

The club of Silverlight Company is divided into front hall, center hall and back hall, 1~16 axis part of the front hall and center hall (originally for the club meeting place) was built in 1968, and the back hall was expanded to increase the 16~20 axis part (originally for the club dressing room) in 1981; the structural form is a single-storey open house. The total area of the building is 1821.6m², the total length of the building (axial dimension) is 60.4m, the width (axial dimension) is 30.0m, the height of the first floor of the front hall is 5.45m, the height of the second floor is 4.0m, and the height of the roof ridge is 13.2m; the height of the ridge of the middle hall is 13.2m, and the height of the gable end is 8.0m; the height of the first floor of the rear hall is 3.5m, and the height of the second floor is 3.75m. The height difference between indoor and outdoor is 0.6m, and the layout is shown in Figure 1.
