# Microstructural Characterization and Cause Analysis of Fracture Surface Burrs in Lockbolts

**Abstract:** Lockbolts are a category of rivets widely applied in bridge steel structures, mining machinery, rail transit and other fields. After installation, its fracture surface must be regular and free of sharp burrs. Previous inspections identified sharp burrs on the fracture surfaces of some production batches after pintail break-off, indicating noncompliance with the product specifications. Samples exhibiting abnormal fracture surfaces were subjected to systematic failure analysis, including low-magnification examination of acid-etched longitudinal sections, longitudinal metallography, macroscopic and microscopic fractography, and energy-dispersive X-ray spectroscopy of longitudinal sections. The abnormal fracture surfaces were ultimately attributed to banded segregation of Mn or C in the lockbolt core. Differences in solute content disrupted the homogeneity of the steel and produced alternating bands with different ductility and toughness. Under tensile loading, sliding along the segregation bands generated axial cracks. These cracks interacted with transverse cracks originating a

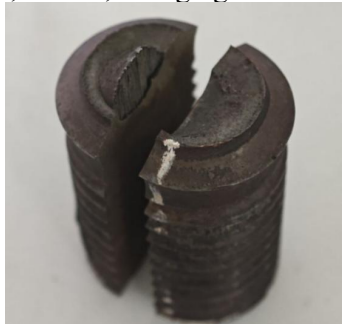
**Figure 4. Schematic of Sample Sectioning**

Lockbolts with particularly severe burrs were selected from the same production batch and sectioned as illustrated in Figure 4. The fracture surfaces were examined first. The macroscopic image in Figure 5 shows a distinct woody fracture morphology. According to the literature [7], woody features on tensile overload fracture surfaces generally indicate elemental segregation or inclusions that deflect the crack propagation path during tension. Industrial experience suggests that an axial woody fracture morphology in the core is associated with corresponding banded features in the material, such as banded martensite, sorbite, or segregation bands.
